## Renewing a Crankshaft After Engine Over Speed.

This describes the replacement of the crankshaft on a 9 cylinder MAN L58/64 engine (580mm bore, 640mm stroke) after the engine over sped and bent the crankshaft.

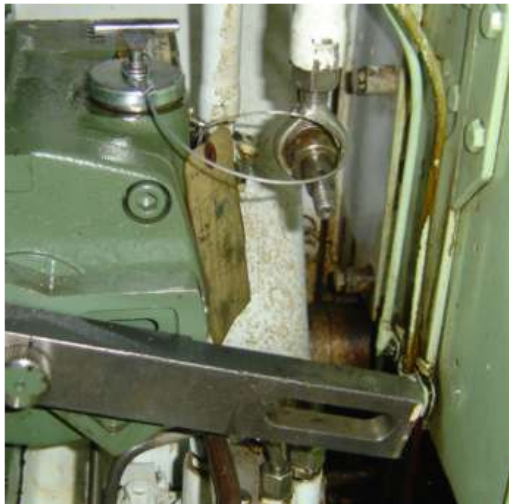
The over speed occurred as a result of a combination of factors from which lessons should be learned. The fuel rack operating arm became detached from the governor control arm because the nut securing it had vibrated loose and eventually fallen off. (see photo opposite).

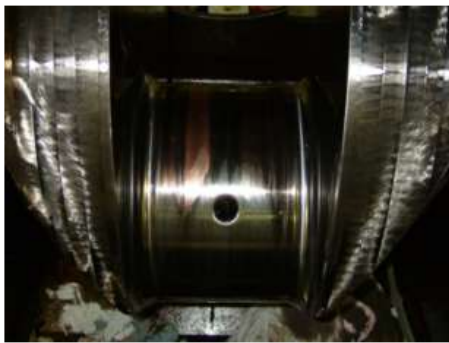
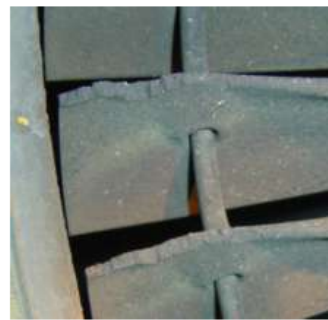
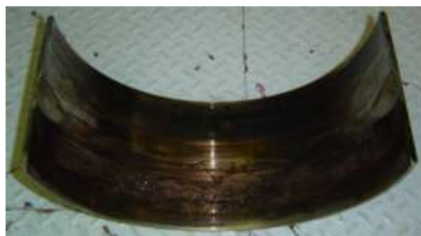
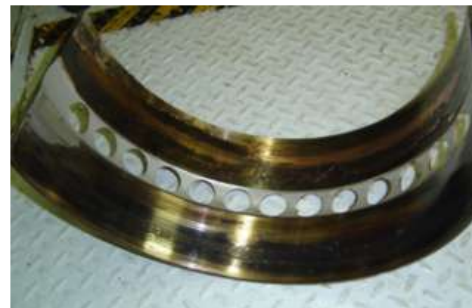
Although the engine was in one piece, on further investigation the crankshaft was found to be bent and it had suffered damage and cracking on some of the bottom journals which had overheated, causing excessive hardness. The valve gear on all the units was damaged, the rocker box covers holed, and the turbocharger blading had been damaged.

The Crankshaft along with all damaged parts were going to have to be replaced. It was decided to do the job without taking the vessel out of service as the engine was one of a multi engine installation, although lifting of the engine for removal and replacement of the crankshaft would be done whilst the vessel was alongside.
